Accessibility Report

Name of business/organisation	Lower Peover Primary School
Address:	The Cobbles Lower Peover Knutsford Cheshire WA16 9PZ
Date of site visit:	Monday 4 November 2019

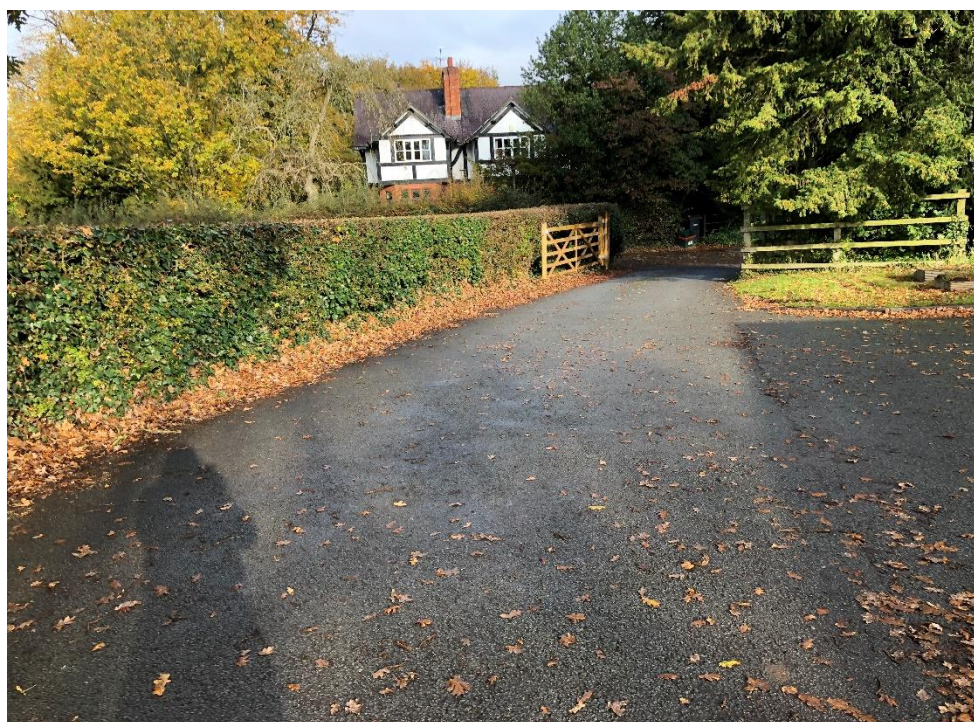
When approaching the school good signage is essential to assist in way-finding to car parks. On the day of the site visit I could not find any signage to identify where the vehicle parking areas were located, which could cause motorists some confusion.

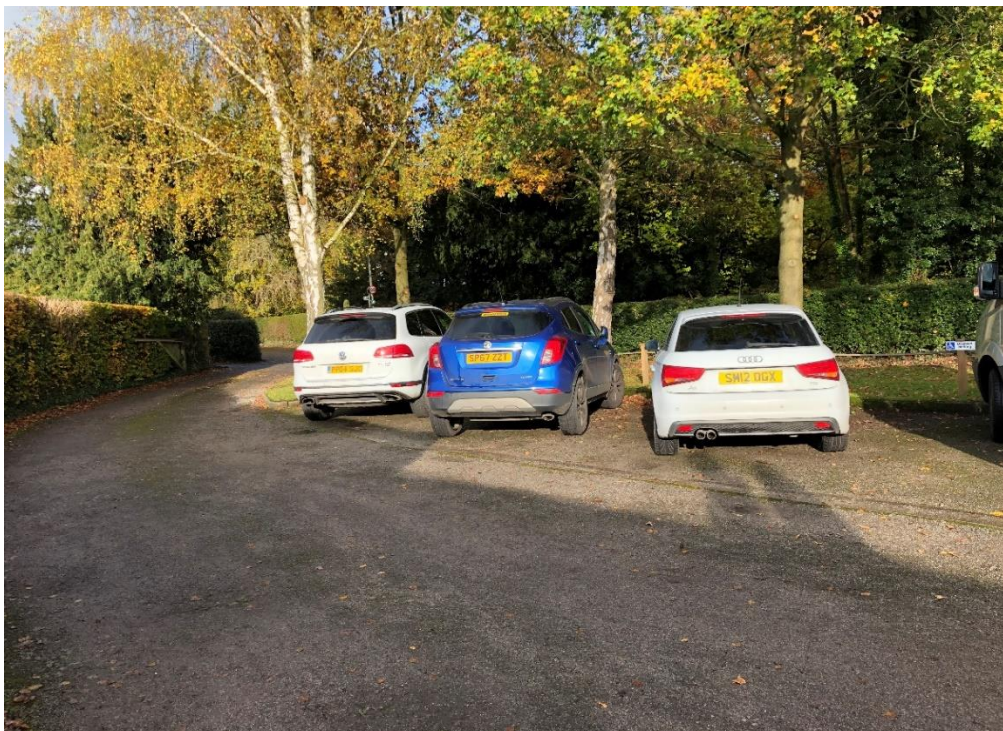
On arrival at the school there is space for four vehicles to park at the front, close to the main school entrance, where there is one designated accessible parking bay. The external signage across the site did not clearly identify where this accessible parking bay was located and the bay itself was not clearly marked.

The accessible parking bay was not adequately sized and at present does not enable vehicle doors to be fully opened. Significantly, a zone of 1200 mm wide had not been provided to enable a disabled driver or passenger to get in or out of a vehicle and safely access the boot, rear hoist or rear access ramp. The location close to where traffic circulates to drop off pupils would make loading and unloading a wheelchair from the rear of a vehicle very difficult at times.

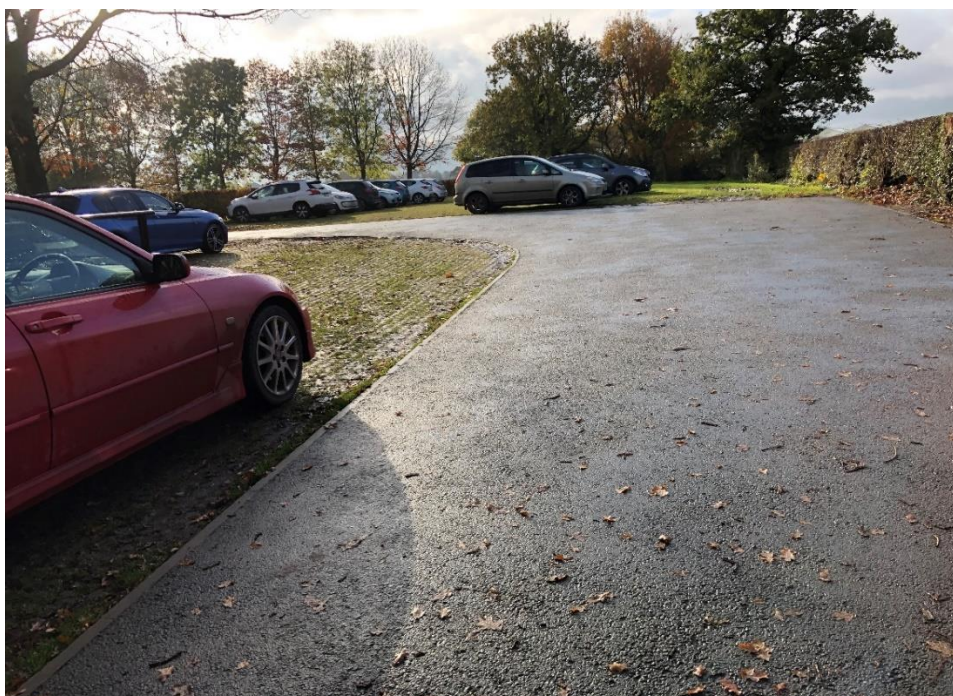
There was a larger parking area at the rear of the school located on the right hand side. This area was previously a field, although a constructed surface had been partially applied at some point.

The route to parking area 2 involved using the road (which was gradually sloping), as there was not an access route which led to it. This would be problematic for disabled people, including those who have mobility impairments and those who are Deaf and hard of hearing, who may not be able to hear vehicles approaching.

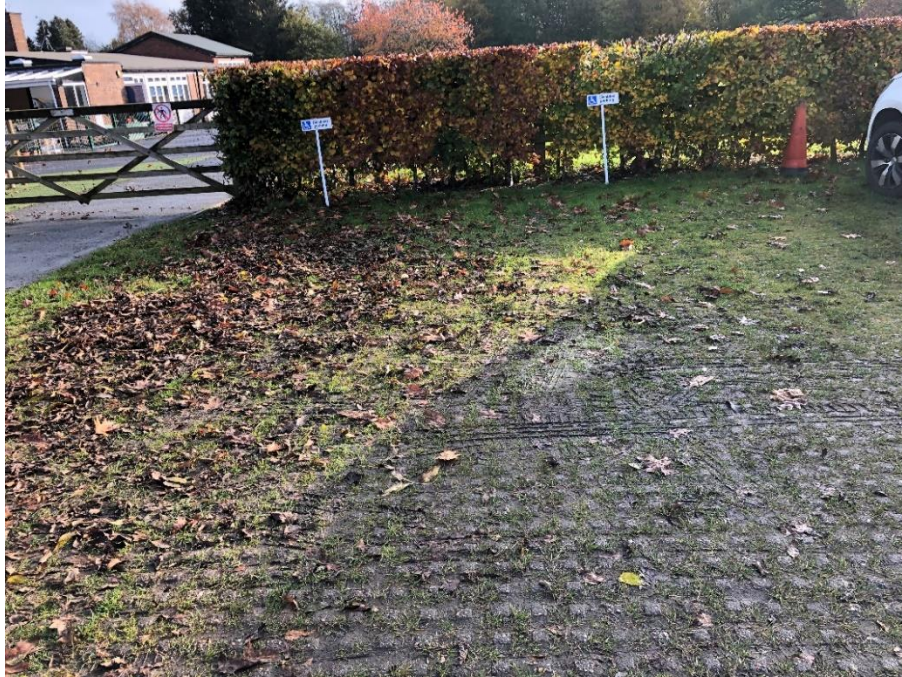
The vehicle parking area and route to/from it did not have a consistently firm, slip-resistant and reasonably smooth surface. Vehicle parking was on grassed areas, which should not be used, as parking on a grassy surfaces will mean that the area will not remain accessible over time and through wet weather conditions.

Approaching and moving around this parking area involved using surfaces that were not firm or slip-resistant to travel on. Moreover, the surface of the parking area did not permit convenient access to/from the parking spaces, or allow for convenient transfer into and from a wheelchair.

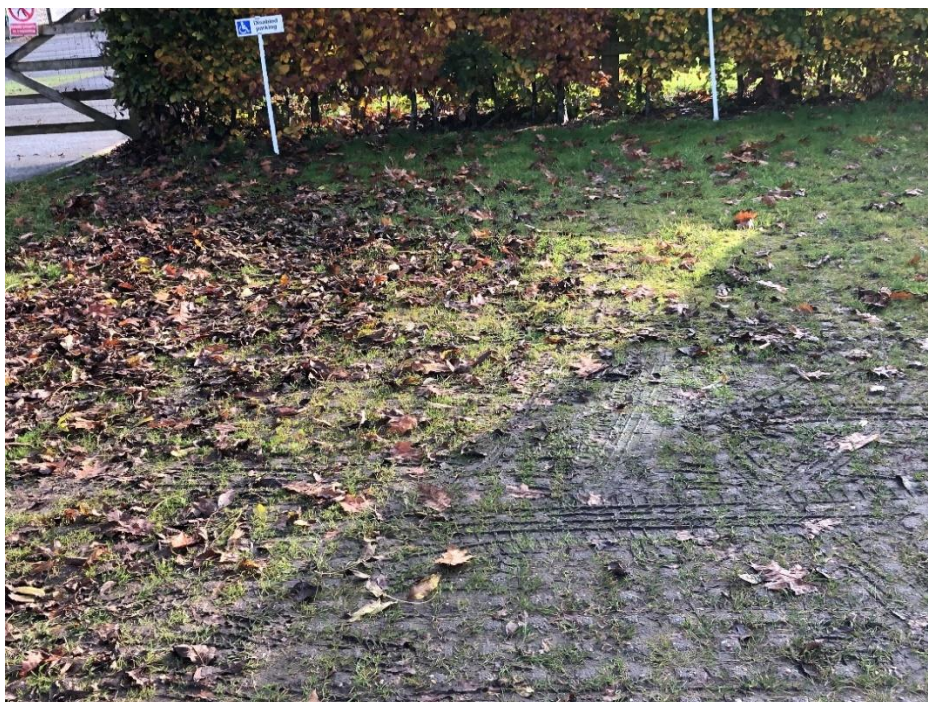
There were two accessible parking bays identified in vehicle parking area 2. A zone of 1200 mm wide had not been provided to enable a disabled driver or passenger to get in or out of a vehicle and safely access the boot, rear hoist or rear access ramp.

There were not any road markings (hatchings) to indicate areas that needed to be kept clear. Both spaces had a 'disabled parking' sign, but these were located low down and not easily identified.

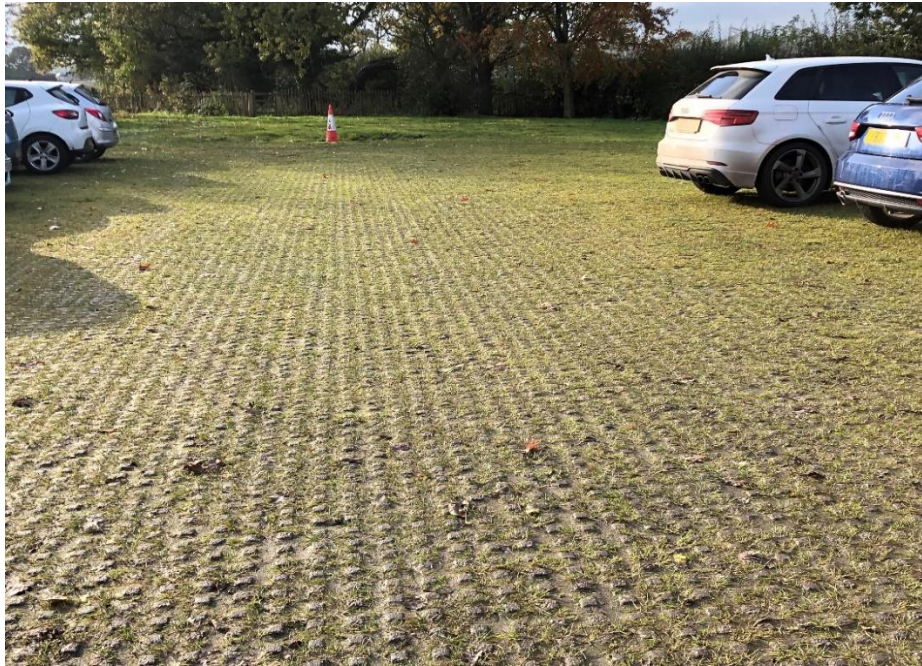
The two accessible parking bays were not located on a durable hard surface which would present difficulties to disabled people.

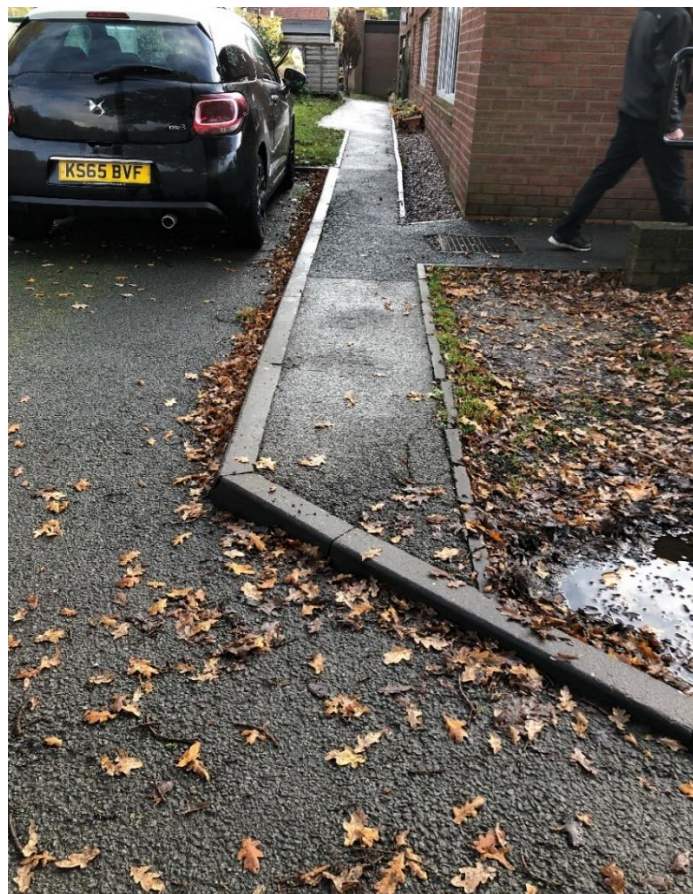
Around the school building there were some narrow approaches. These can create difficulties for disabled people who need a generous amount of space when moving about. Uneven surfaces, surfaces of loose materials (e.g. unbonded gravel) and large gaps between paving materials cause problems for wheelchair users, people who are blind or partially sighted and people who are, generally, unsteady on their feet.

Across the site, there was a lack of clear signage to assist with wayfinding and there did not appear to be a marked pathway for disabled people to follow.

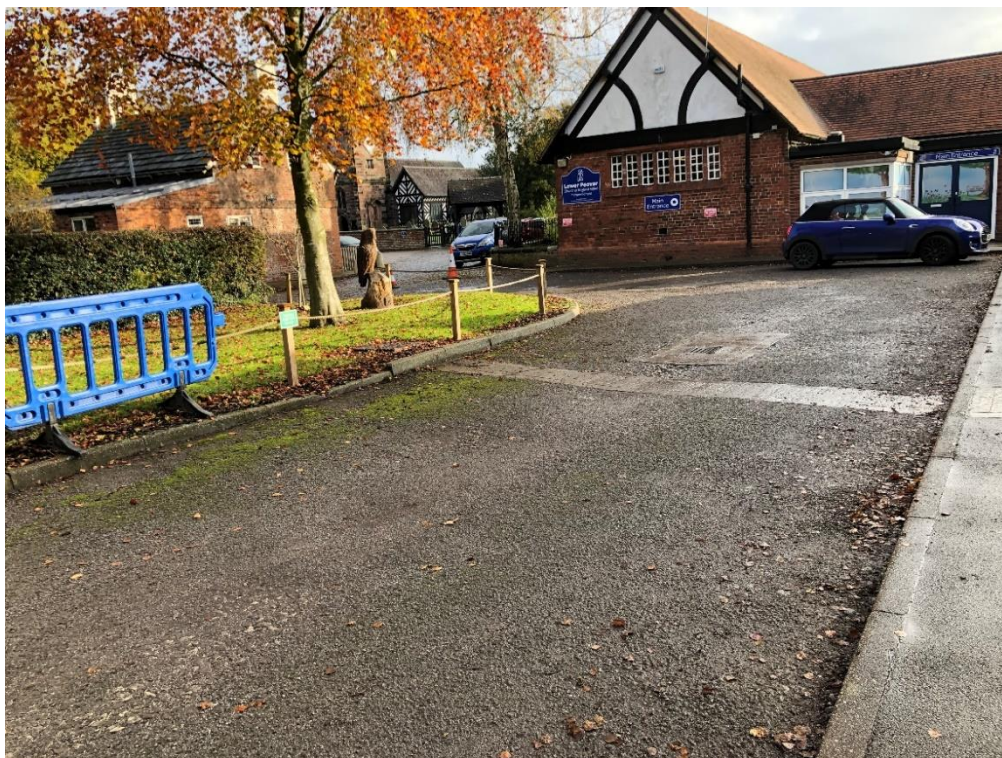
Opposite car parking area 1 there is one dropped kerb on to a footway. Assuming that the area in front of this dropped kerb is kept clear at all times, it is possible for wheelchair users to turn left along the footway and reach the school's main entrance.

From the dropped kerb, turning right along the footway to reach the rear of the building, the footway is too narrow and the cross-fall across the footway makes it more difficult to walk/wheel along.

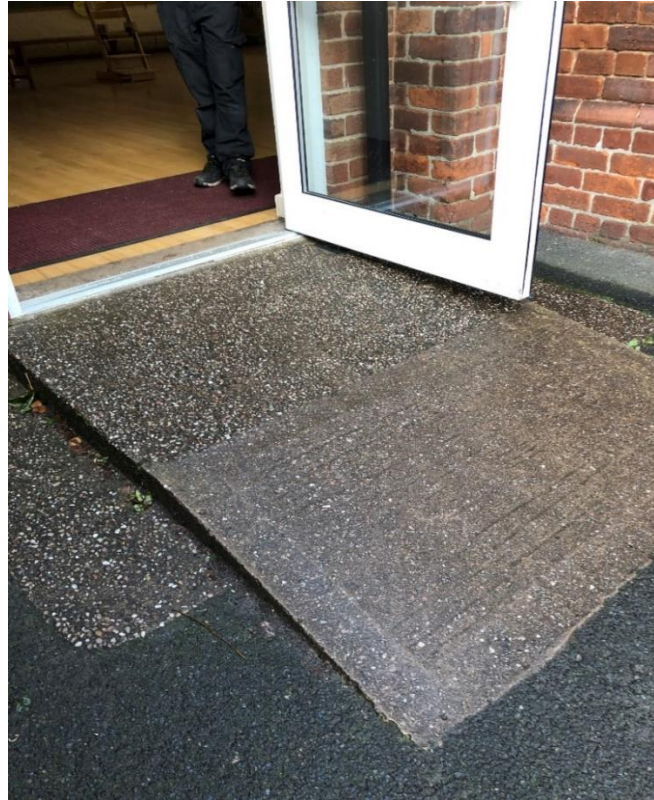
From the school's main hall, there is a single leaf door that opens outwards and leads to the playground outside (also a fire exit). The door was 1000mm wide, but the surface width of the ramp was less than stated in BS 8300 Code of Practice.

In order to facilitate movement in this location, a ramp was the only viable means of access as it avoided the need for a step. Whilst in this location a ramp was necessary, its existence and location were not clearly indicated as a person approaches.

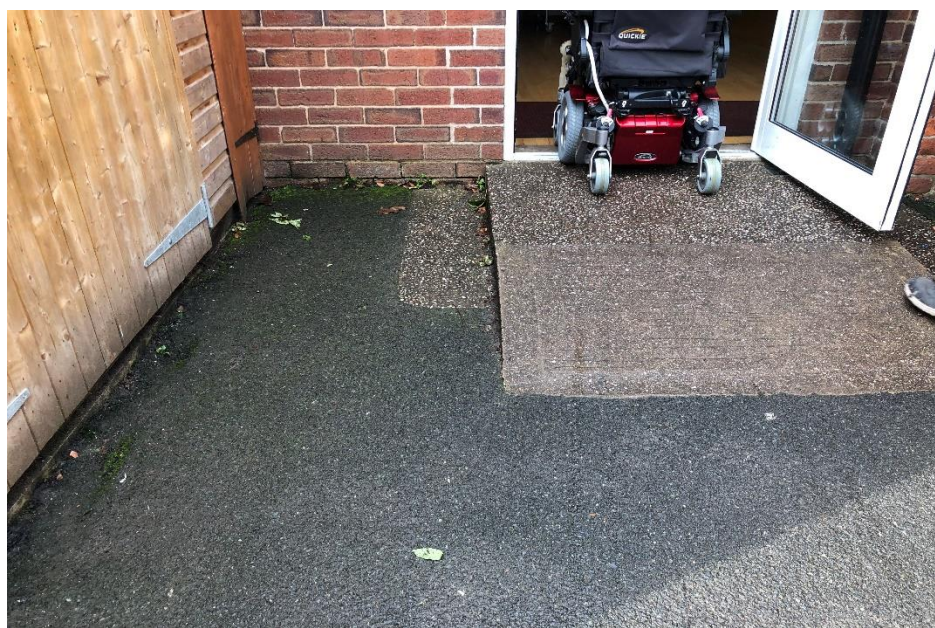
The ramp had a practicable gradient within the guidance range.

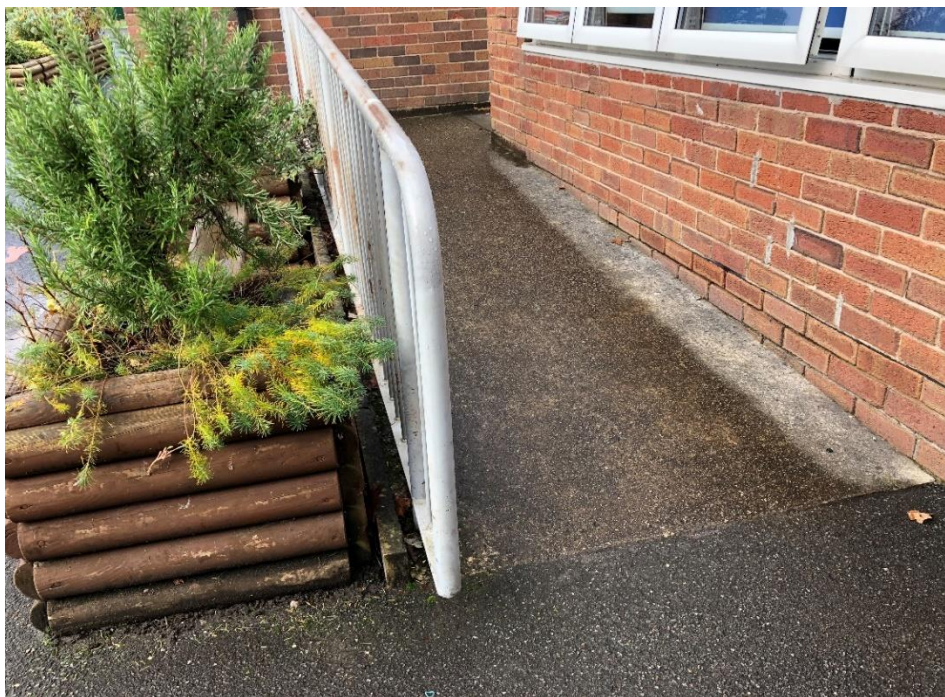
From Year 6 Classroom, there is a single leaf door (also a fire exit) that opens outwards on to a landing. From the landing there is a 90° turn to the left down a ramp which leads to the playground area. The surface width of the ramp was less than stated in BS 8300.

In order to facilitate movement in this location, a ramp was the only viable means of access as it avoided the need for a several steps, but its existence and location were not clearly indicated as a person approaches.

A landing was provided at the head of the ramp that was the width of the ramp, but it was not clear of the door swing. There was not a landing at the foot of the ramp.

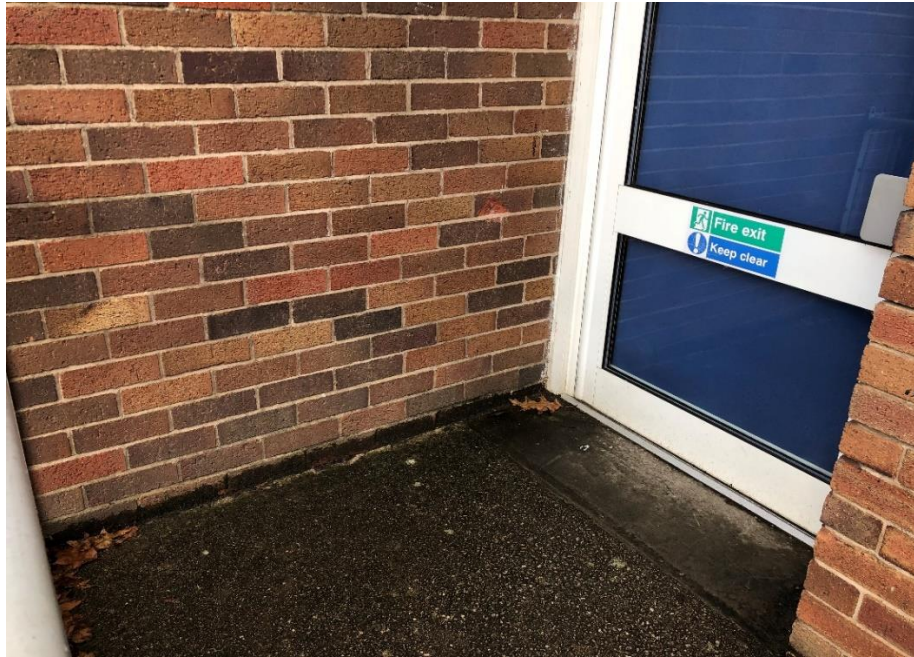
The top landing was the width of the ramp and less than 1500 mm long, clear of any door swing or other obstruction.

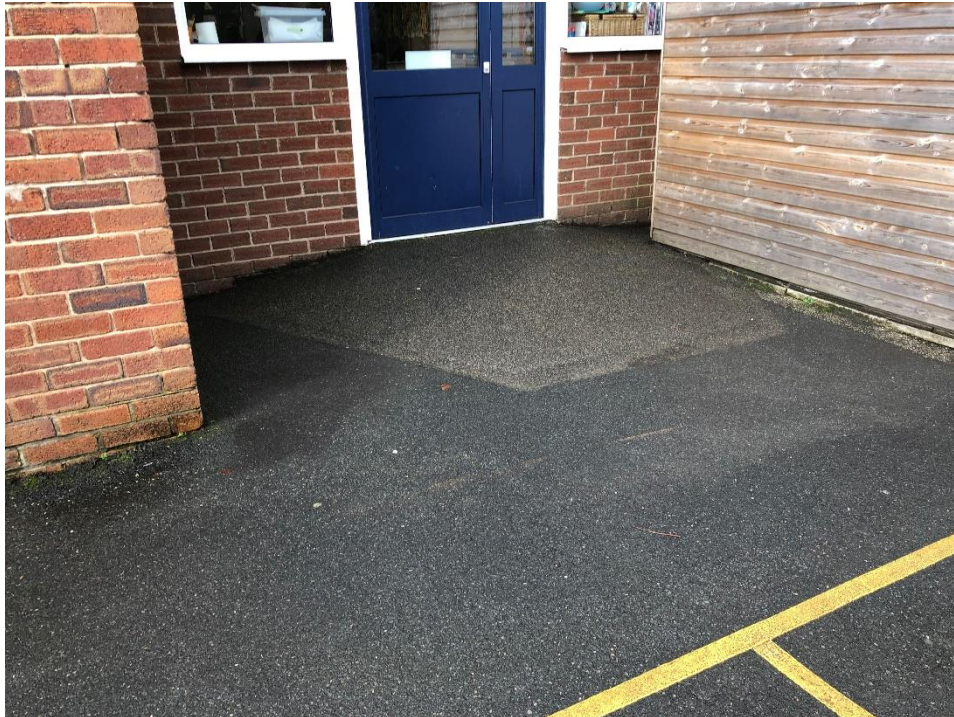
This ramp did not incorporate a continuous detectable physical edge which people who are blind or partially sighted can follow. The lack of edge protection where there is a change in level means there is a risk of falling, and appropriate measures had not been taken to address this.

Landings had not been provided at the foot and head of the ramp. The top of the ramp was not clear of the door swing and the foot of the ramp was within the playground area.

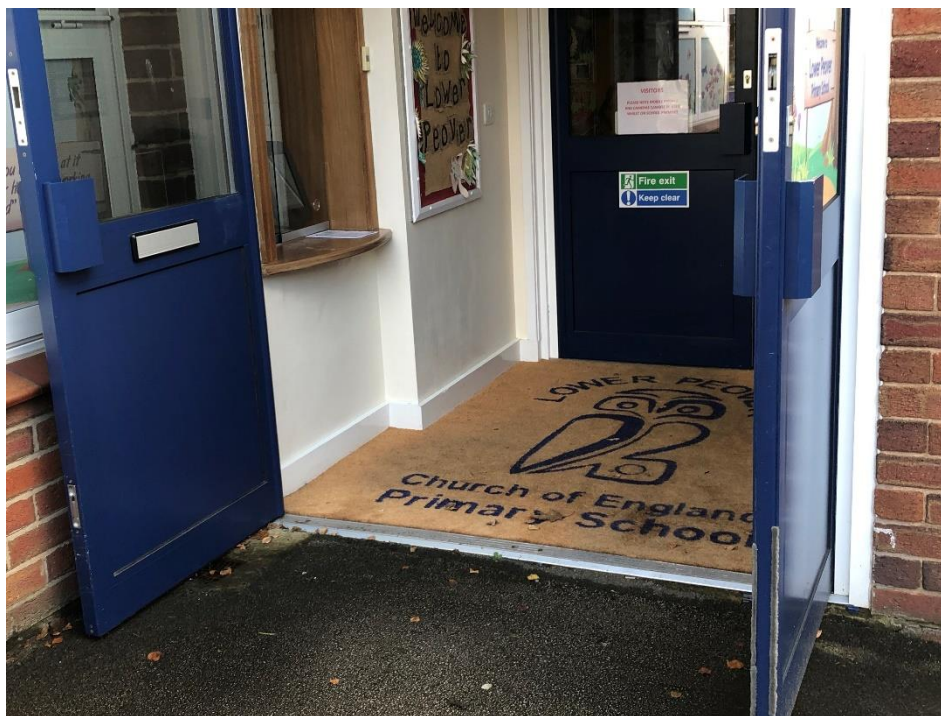
On approach, the main entrance could be located, but the door handles did not provide visual contrast with the doors.

At the threshold there was step-free access, although the threshold was slightly raised on the right hand side.

The weather mat appeared to be of a firm durable material and was inset, so did not present a trip hazard.

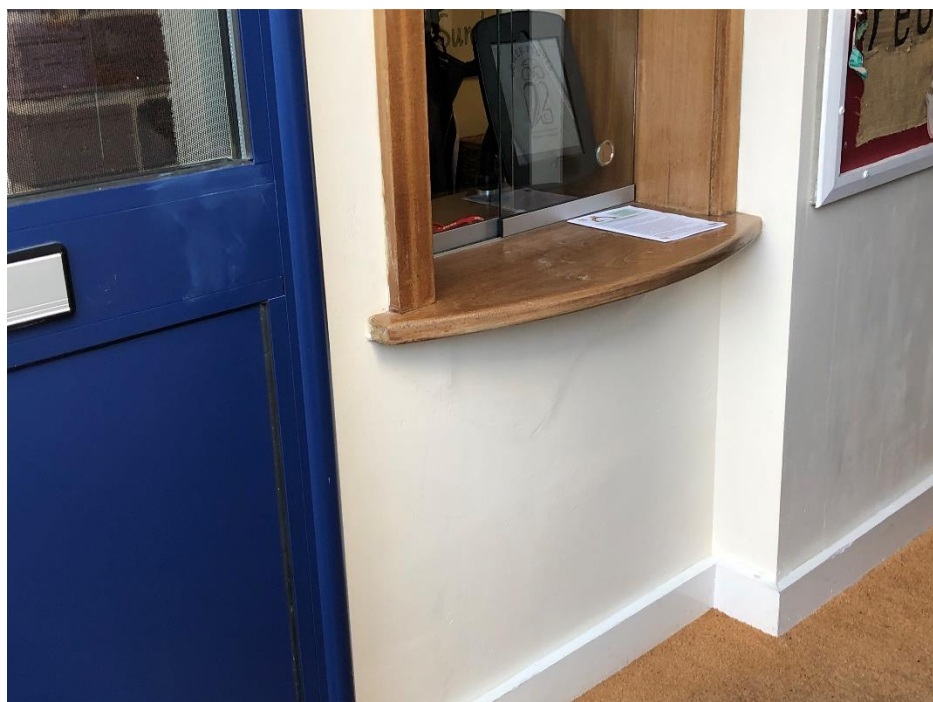
The entrance did not incorporate a form of weather protection, such as a canopy, to provide shelter for those having to pause before entering the school building, hence anyone waiting for the doors to be manually operated is exposed to the weather.

There was a small lobby area between the outer entrance doors and the inner lobby door. This lobby area was very cramped and had a protruding counter sill. The counter would not be easily identifiable from the building entrance by people who are blind or partially sighted.

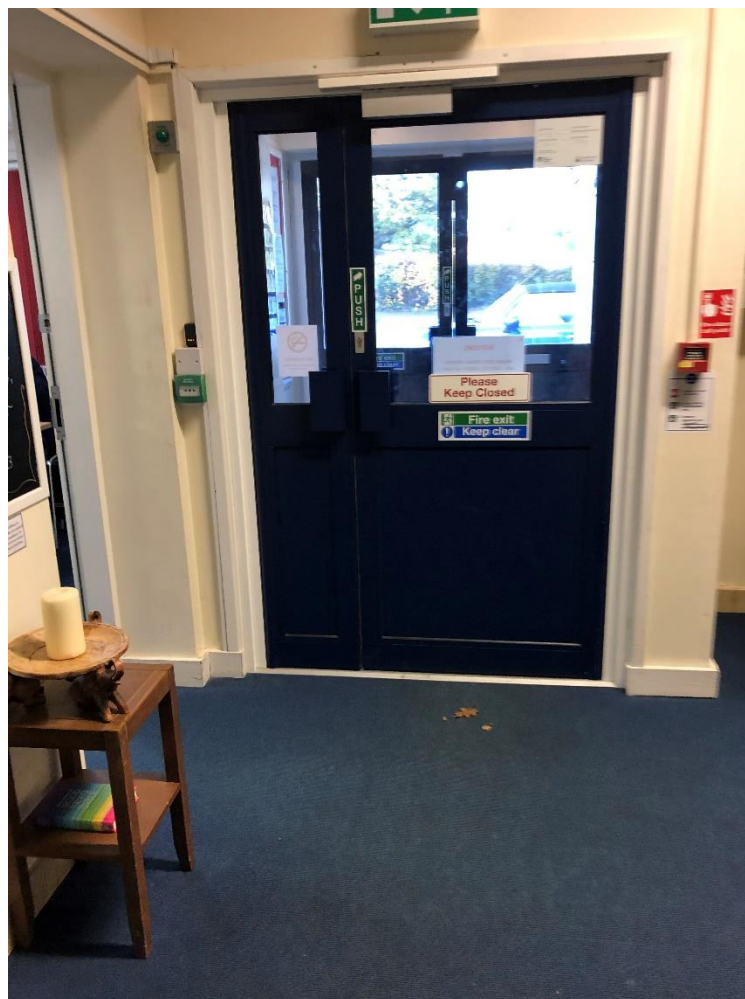
I did not see a sign indicating that a system to assist hearing aid users (such as an induction loop) was available.

The inner door leading from the lobby to the inside of the school building opened outwards into the cramped lobby area, this door also had to be manually operated.

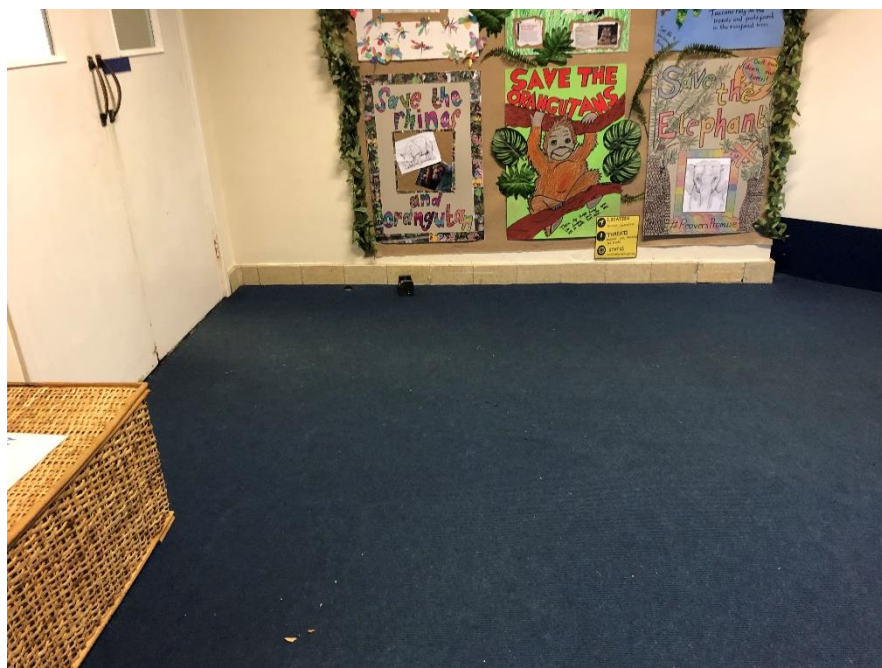
Factors which can help to minimize the need for assistance on entering a building includes the ease with which visitors can identify their intended destination once inside. For example, clear signs and information are essential for people who are Deaf and hard of hearing who might be unable to ask, or feel uncomfortable about asking, for directions.

The inner door from the lobby takes visitors directly into a corridor with several doors leading to different spaces, including the accessible toilet, staff office, resource room, main hall and head teachers' office. The different rooms and spaces leading from the corridor were not clearly identified by signage. Therefore it would be difficult for disabled visitors (and others) to find the room they required.

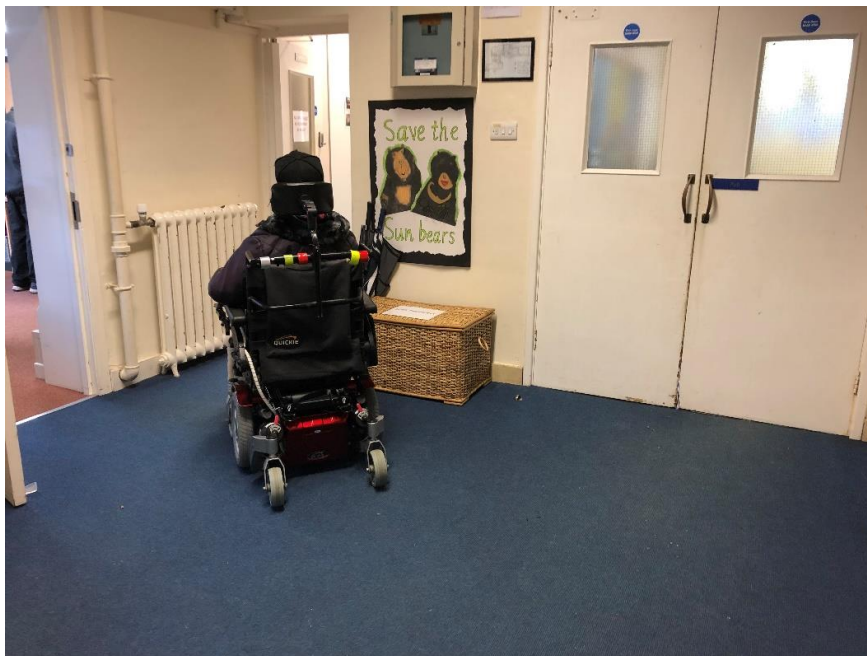
It is important that visitors to the building who might be unfamiliar with the layout are able to orient themselves, identify their desired destination and find the route to it. The ease of orientation in, and way-finding around a building should be supported by information systems and signage, but I was unable to locate a way-finding strategy at the school.

People need clear information about the purpose and layout of spaces if they are to maintain a clear sense of direction and independent use of a building, however there did not appear to be a map showing the layout within the building, including access information, at the entrance or elsewhere.

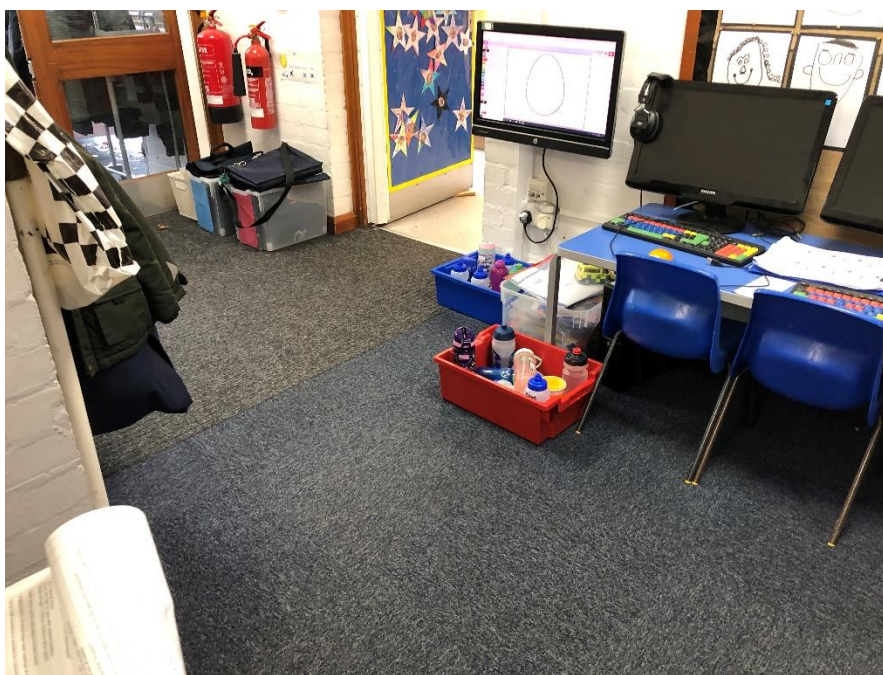
The corridor ran along the length of the school through a right-hand turn and two left hand turns. The passageway would present barriers to disabled people who would not find their way unimpeded. Obstructions, such as bookcases, boxes and trolleys were located along the route, which are particularly hazardous for a person who is blind or partially sighted, even when using a cane. Furthermore, there needs to be sufficient space to provide room for efficient wheelchair turning (1500 × 1500 mm) and to provide convenient access to rooms.

There were some moveable items in areas where they could impede access and circulation (particularly those that were close to classroom entrances). These would be particularly hazardous for a person who is blind or partially sighted, even when using a cane, although relocating these items would benefit everyone.

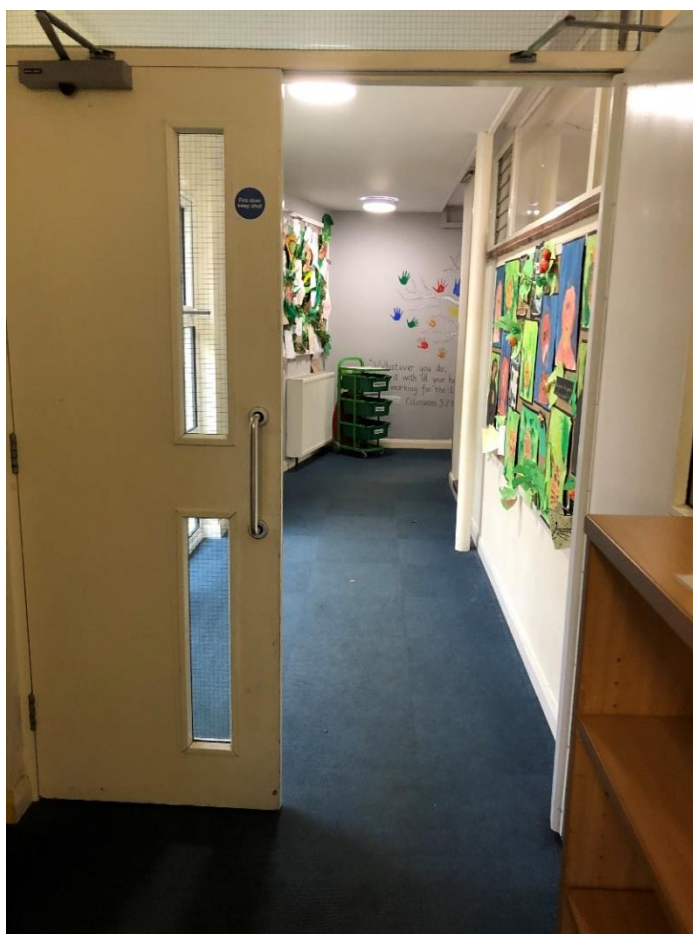
The doors across the corridor, which were fire-resisting doors, had viewing panels, but did not have a significant level of visual contrast. They were not fitted with door closers and some were held open manually.

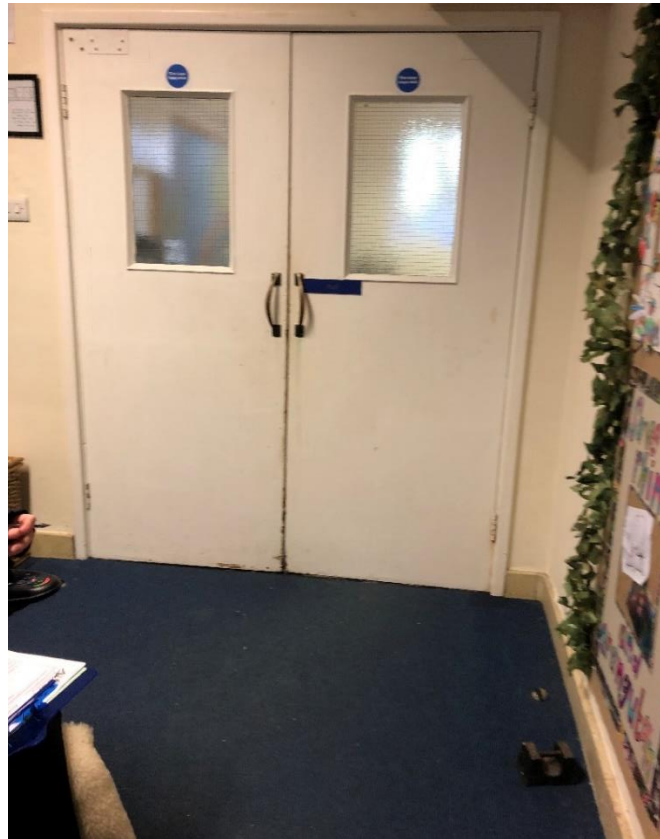
After entering the school through the main entrance, the hall is located through a set of double doors on the left hand side of the corridor. Each door leaf measured 760 mm, which is below the required minimum effective clear width, meaning that both doors would have to be opened in order to facilitate wheelchair access.

The hall doors open towards a frequently used corridor, but were not located in a recess (which should be at least as deep as the width of the door leaf).

Ensure that at least one of the doors leading to the hall has a minimum effective clear width of 1000 mm. A lesser effective clear width of 800 mm can result in people with poor manoeuvring ability or with large wheelchairs not being able to pass through without damage to themselves or the door or frame. Use of the 1000 mm effective clear width more easily accommodates electric mobility scooters, powered wheelchairs, double pushchairs, people with assistance dogs and where there is heavy foot traffic, such as a school hall. If a building is used by the general public, BS 8300 states that the greater effective clear width is likely to be best achieved using power-assisted doors -

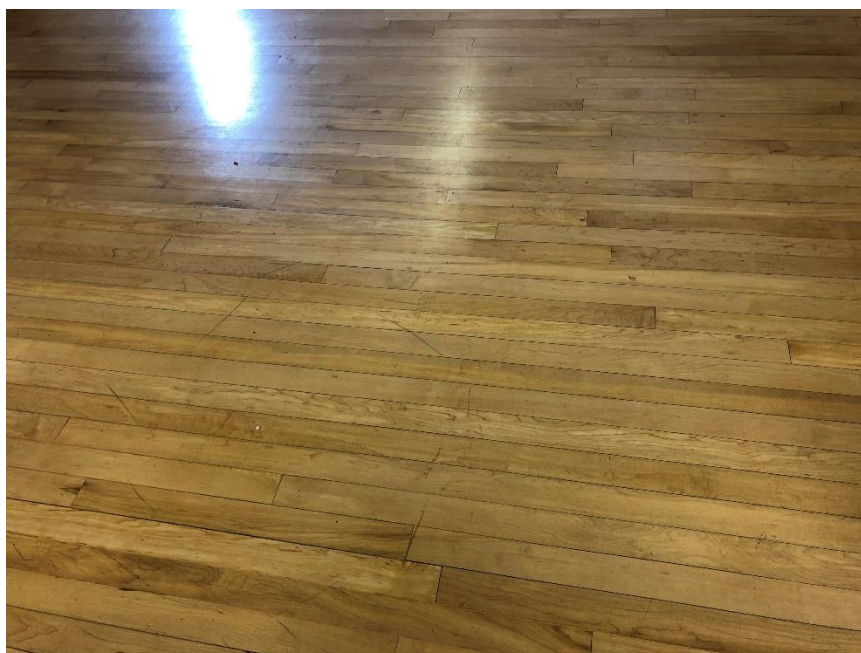
I was advised that the hall flooring had recently been renovated. It is important to note that wear, usage, potential contamination, cleaning and maintenance regimes, will all have an impact on the floor surface, in terms of slip resistance. The hall floor appeared to have reasonably firm surface and allowed for easy manoeuvre of a wheelchair.

The floor surface had a very shiny finish, which could cause problems with glare and the fact that it is perceived as being slippery even if the flooring has a slip-resistant surface.

Select hall flooring that ensures, as far as is possible, that traction beneath the foot can be maintained under conditions of use. Floor surfaces should offer a level of slip resistance that provides a firm foothold and good wheel grip under normal conditions of use -

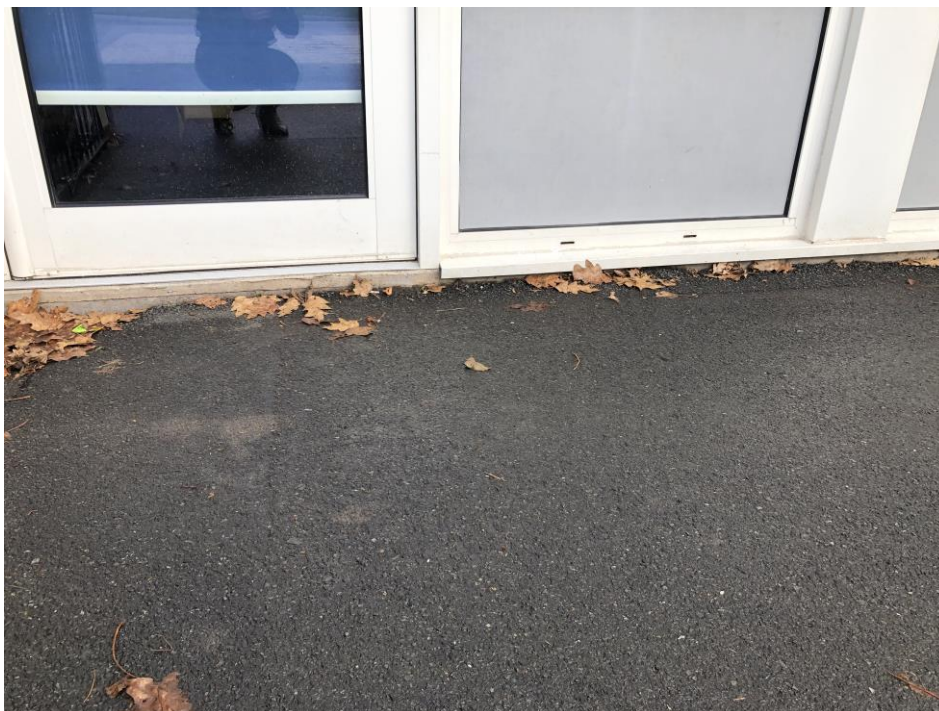
The route from Year 5 classroom through to the playground area was not an accessible, step-free route. At the doorway (fire exit) there was a step down of 65 mm.

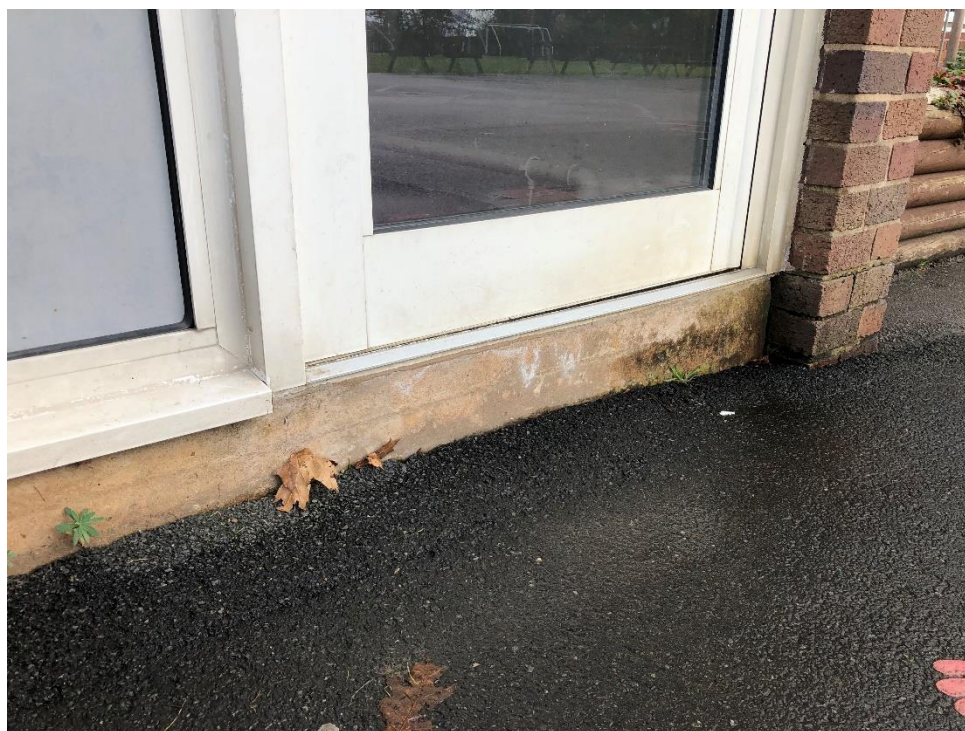
The route from Year 4 classroom through to the playground area was not an accessible, step-free route. At the doorway (fire exit) there was a step down of 160 mm.

Sudden changes in level at doorways should be avoided as, even when highlighted using visual contrast, they present a significant trip hazard. People who are blind or partially sighted risk tripping or losing their balance if unaware of steps. As the step in both cases led to the external environment, there was further risk due to exposure conditions and the lack of weather protection. Thus, where there is a change in level less than 300 mm, the change should be accommodated by a ramp.

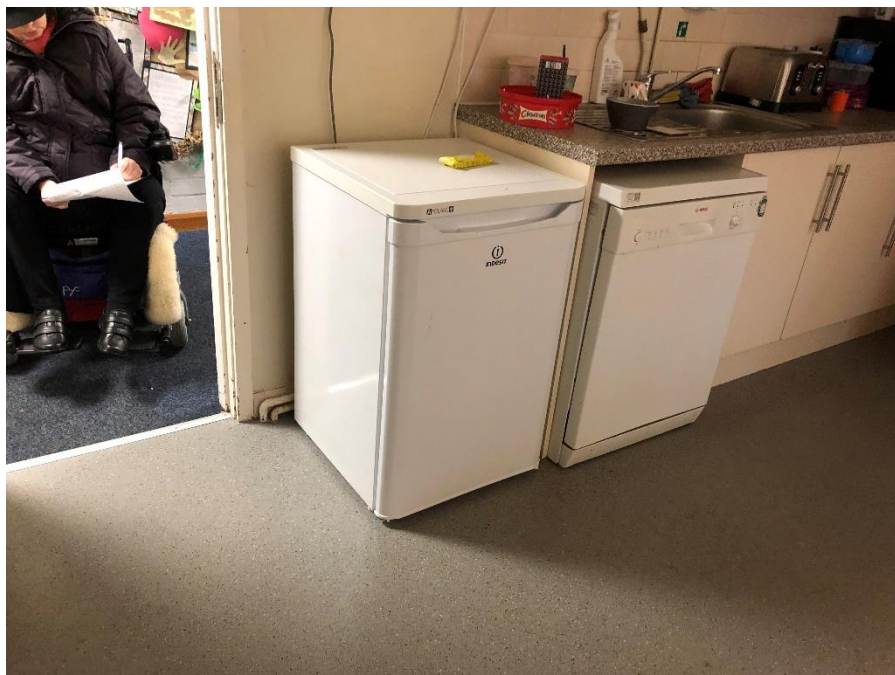
The entrance to the staff room from the corridor was narrow, with a width of 640 mm and I was unable to enter the room in my wheelchair.

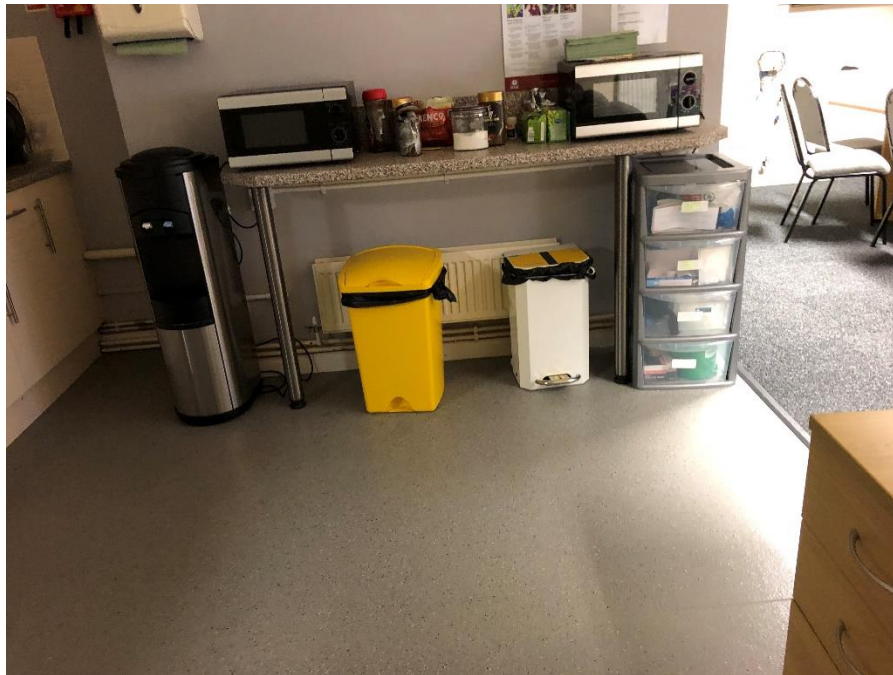
The confined space, poor visibility and obstructions are other key factors within the staff room that would act as barriers to disabled people, particularly people with mobility impairments, or who are blind or partially sighted.

Ensure that the approach to the edge of the kitchen counter and the seating area in the staff room are unobstructed -

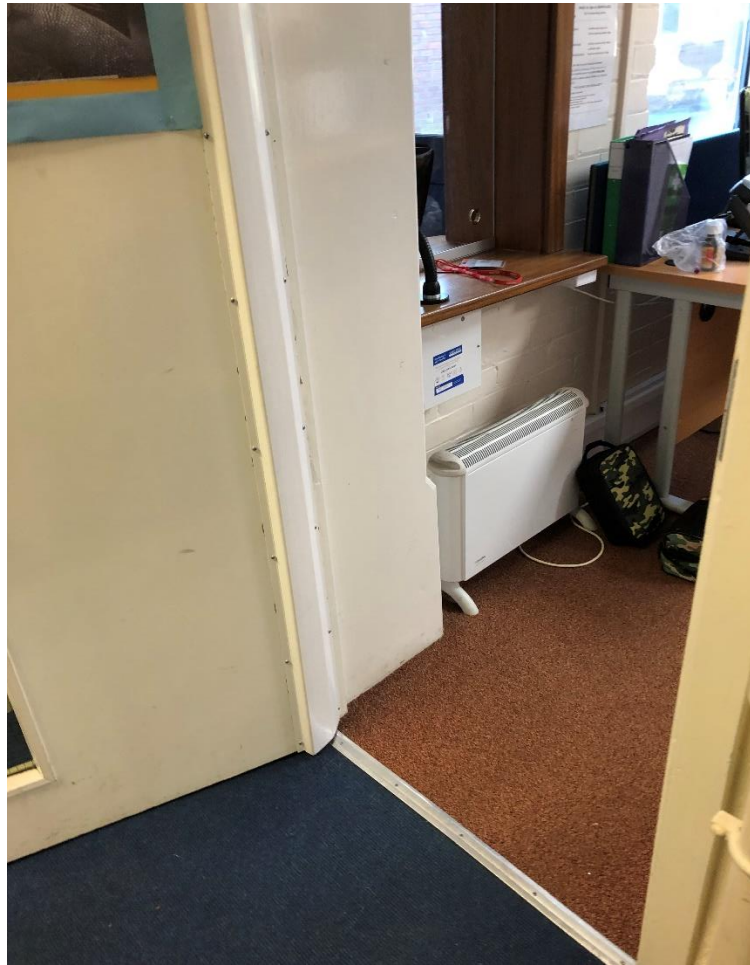
Not all internal doors were easy and light to open and some required a degree of strength, which can cause significant difficulties for a wide range of people, including children. It is extremely difficult for wheelchair users, and for people who use walking aids or assistance dogs, or who have limited strength or poor standing tolerance, to manoeuvre through the force exerted by the door.

Where door entry systems were installed, either security key pads or ones operated by employees passing a key fob across a pad, they were located above the recommended height and many people would not be able to access them (for example, wheelchair users, people of short stature or with reduced arm and shoulder movement).

During the site visit it was noted that many of the doors did not provide visual contrast to identify features against the wall surfaces surrounding the doorway.

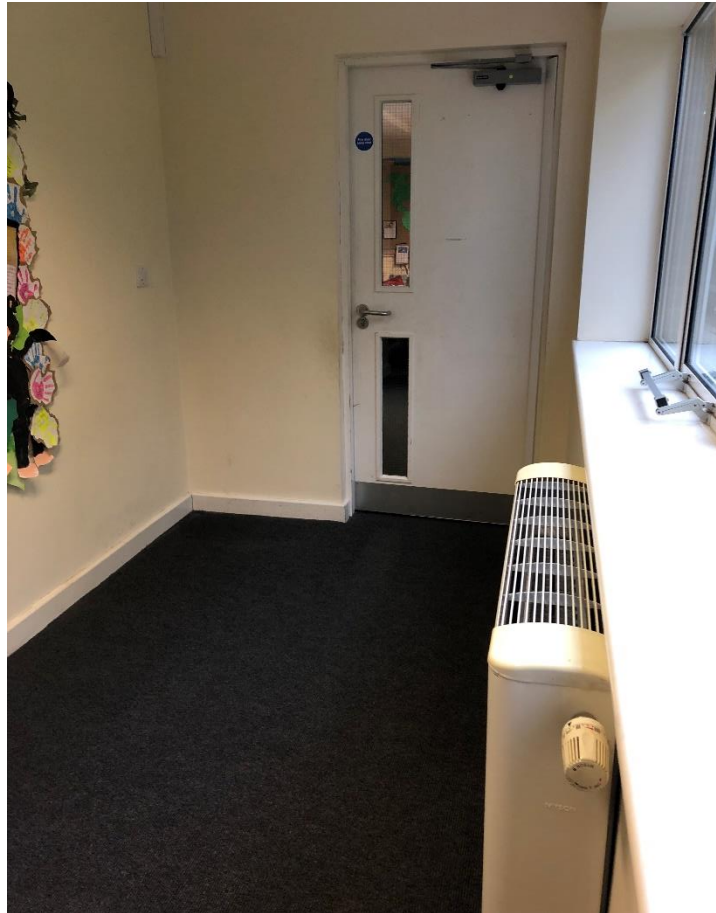
The ability of fire-resisting doors to perform their designated function depends on their being fully closed at the time of fire. To ensure closure, it is necessary for them to be fitted with a controlled door closing device, irrespective of whether the door is latched or unlatched.

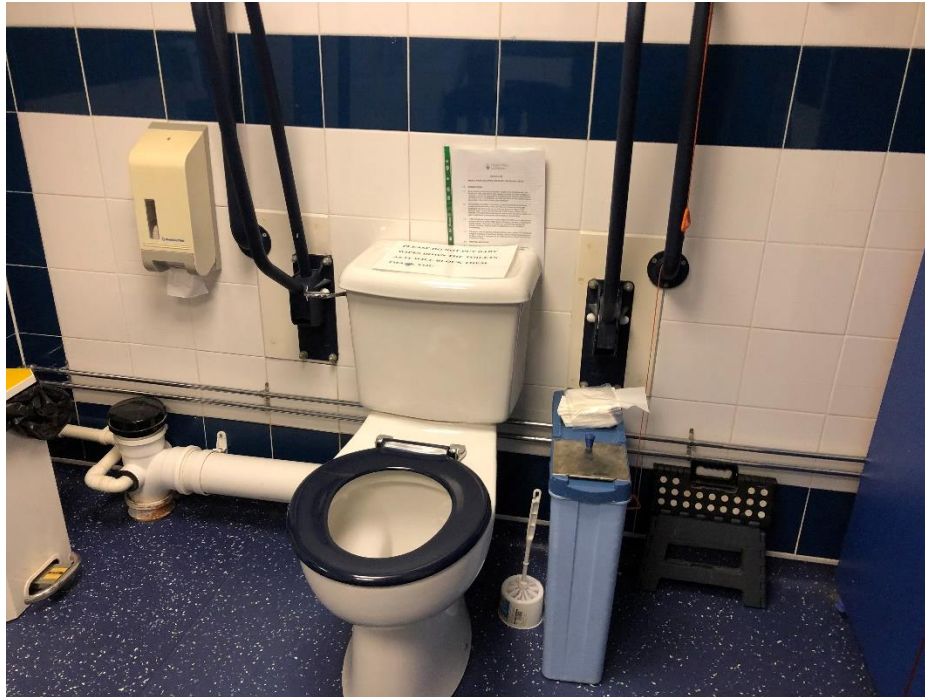
BS 8300 states that this type of peninsular WC layout is appropriate only when an assistant is available, because drop-down support rails are not considered to give sufficient support for independent transfer and it is not possible to rinse hands when seated on the WC. Furthermore, the absence of a side wall can give rise to feelings of insecurity.

It is recommended that a single unisex accessible toilet with a peninsular WC layout for assisted use should not be provided as a substitute for separate unisex accessible toilets with handed corner layouts, or for a Changing Places toilet. If such a toilet layout is provided, it should be as an additional facility, not the sole facility.
