Accessibility Report

Name of business/organisation	Lower Peover Primary School
Address:	The Cobbles Lower Peover Knutsford Cheshire WA16 9PZ
Date of site visit:	Monday 4 November 2019

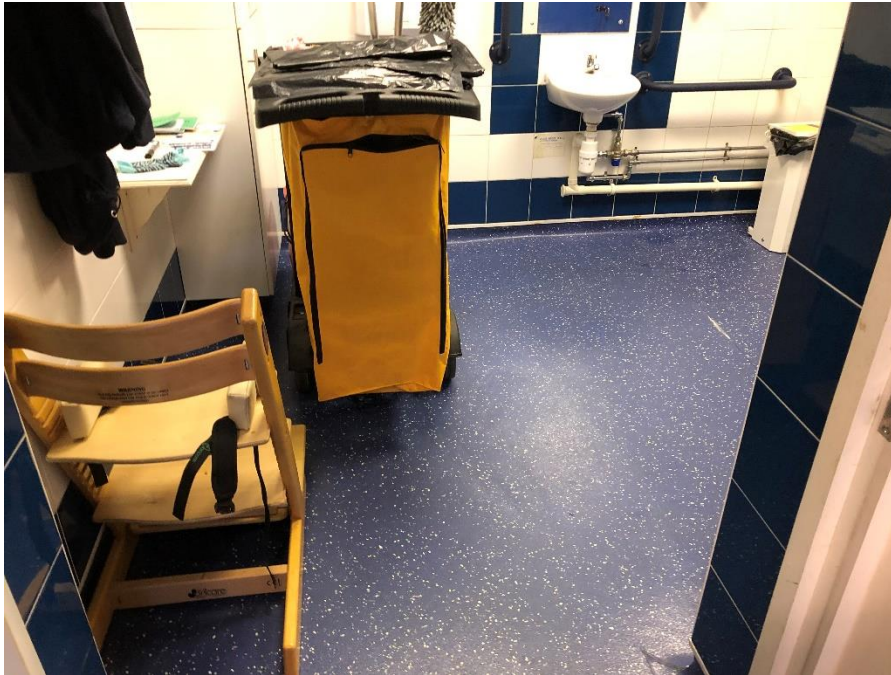
Cleaning staff and other employees did not appear to be aware of common issues, such as keeping the entry to the toilet free and storing cleaning equipment elsewhere.

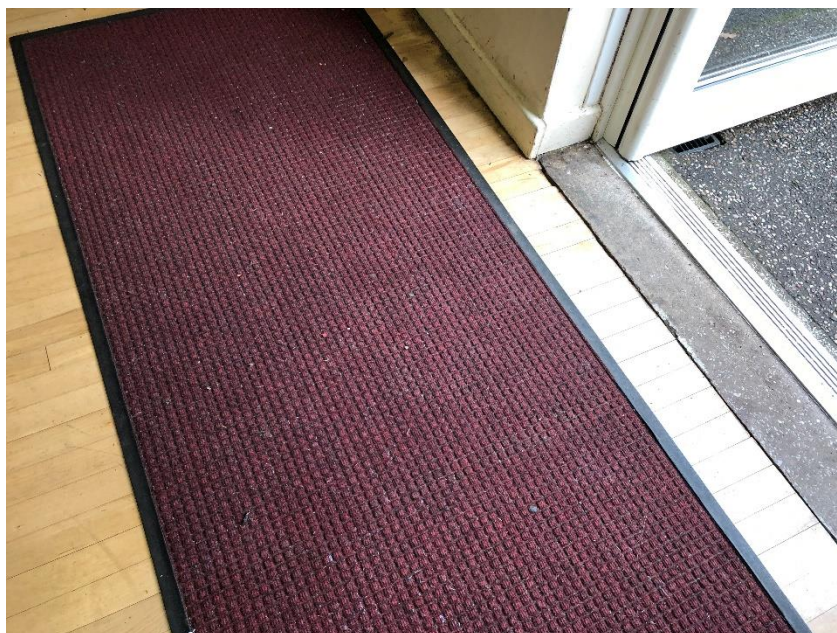
Some of the floor surfaces had loose mats, which could be unsafe for disabled people.

Avoid using loose matting, particularly at entrances, wherever possible -
