Accessibility Report

Name of business/organisation	Lower Peover Primary School
Address:	The Cobbles Lower Peover Knutsford Cheshire WA16 9PZ
Date of site visit:	Monday 4 November 2019

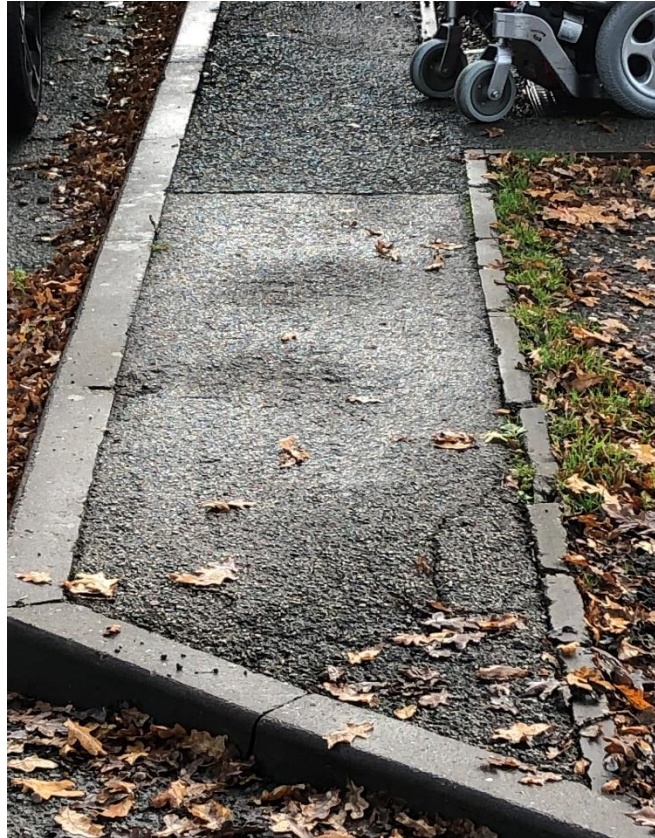
Around the school building there were some narrow approaches. These can create difficulties for disabled people who need a generous amount of space when moving about. Uneven surfaces, surfaces of loose materials (e.g. unbonded gravel) and large gaps between paving materials cause problems for wheelchair users, people who are blind or partially sighted and people who are, generally, unsteady on their feet.

Ensure, wherever possible, that the minimum surface width of an access route is at least 1800 mm and install dropped kerbs along pathways where required, particularly at the end. Keep dropped kerbs and access routes free of obstructions.

Priority 4: Implement as part of specific regular maintenance/renewal.
